**Flood Control Project Maintenance  
Levee Inspections**

**Maintenance Issue Types Only, Levee Inspection Report By Mile - Fall 2015**

**Sacramento Maintenance Yard Willow Slough Bypass**

Waterway	Bank	Unit Miles	Inspection Start/End	Inspector
Unit No. 01 Willow Slough Bypass or North Levee	Left	5.05	10/15/2015 10/15/2015	Jai Lor

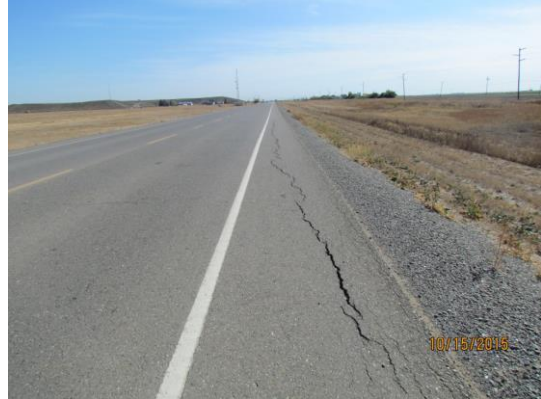
Photo 1 of 3 : FA\_2015\_ST0012\_295\_15\_20151019\_00014.jpg

LM Start	1.86	Rating **	A/W	Issue No.	15
LM End	1.88	Issue Type +	Ma	Location *	CR
Category	Earthen Levee			GPS Latitude/Longitude	
				Start	End
Item	Cracking			38.590378 °	38.590379 °
				-121.699630 °	-121.699920 °
DWR ID	DWR_ST0012_01_f_2015_15				
Action/Comments					
Monitor and have inspected by geotechnical engineer.					
Inspector Comments: Cracks starting to form on the waterward slope.

Perspective view of the crack on the crown of the levee looking downstream. Fall 2015.

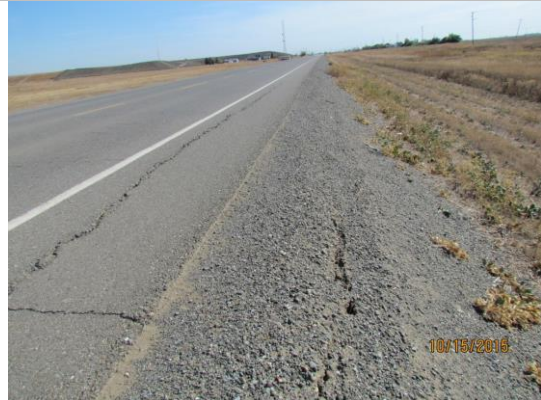
Photo 2 of 3 : FA\_2015\_ST0012\_295\_15\_20151019\_00018.jpg

Cracks are starting to form on the waterward slope of the levee looking downstream. Fall 2015.

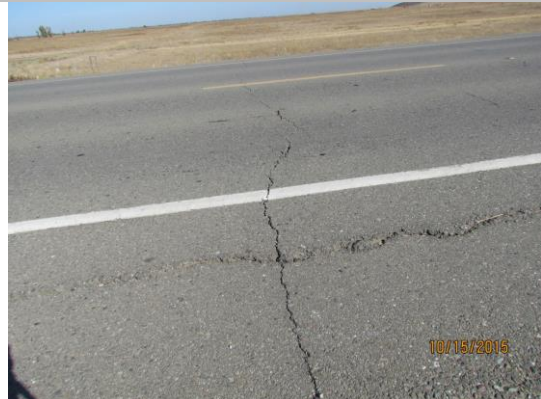
Photo 3 of 3 : FA\_2015\_ST0012\_295\_15\_20151019\_00019.jpg

There is another crack perpendicular to the crack on the levee crown. Fall 2015.

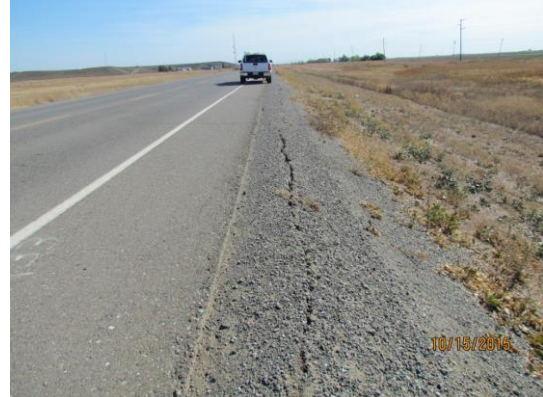
Photo 1 of 1 : FA\_2015\_ST0012\_295\_14\_20151019\_00022.jpg

LM Start	1.88	Rating **	A/W	Issue No.	14
LM End	1.89	Issue Type +	Ma	Location *	WS
Category	Earthen Levee			GPS Latitude/Longitude	
				Start	End
Item	Cracking			38.590382 °	38.590387 °
				-121.700075 °	-121.700233 °
DWR ID	DWR_ST0012_01_f_ 2015_14				
Action/Comments					
Monitor and have inspected by geotechnical engineer.

View of the crack on the waterward side of the levee looking downstream. Fall 2015.

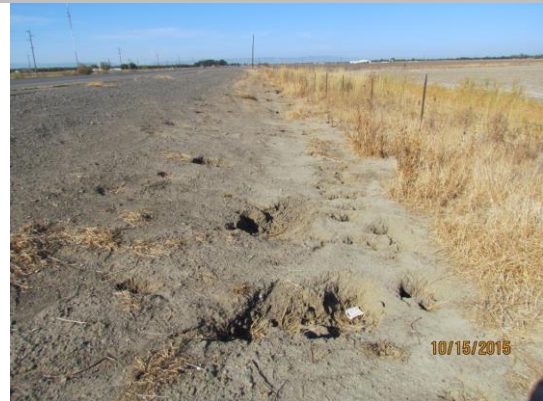
Photo 1 of 1 : FA\_2015\_ST0012\_295\_10\_20151019\_00013.jpg

LM Start	2.93	Rating **	M	Issue No.	10
LM End	3.00	Issue Type +	Ma	Location *	LS
Category	Earthen Levee			GPS Latitude/Longitude	
				Start	End
Item	Erosion / Bank Caving			38.590572 °	38.590653 °
				-121.719349 °	-121.720714 °
DWR ID	DWR_ST0012_01_s_2015_10				
Action/Comments					
Schedule repair of erosion site prior to the next inspection.

View of the erosion on the landward side of the levee looking upstream. Fall 2015.

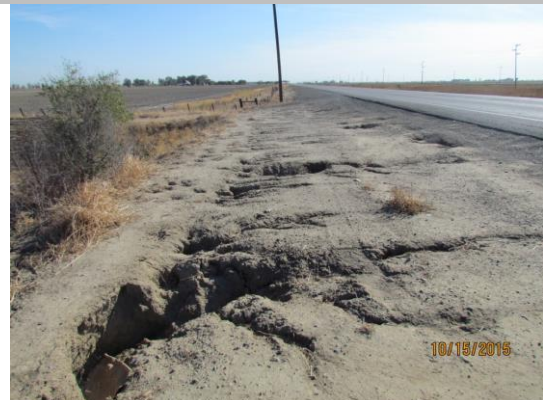
Photo 1 of 3 : FA\_2015\_ST0012\_295\_13\_20151019\_00009.jpg

LM Start	3.04	Rating **	U	Issue No.	13
LM End	3.04	Issue Type +	Ma	Location *	LS
Category	Earthen Levee			GPS Latitude/Longitude	
				Start	End
Item	Erosion / Bank Caving			38.590660 °	38.590660 °
				-121.721460 °	-121.721460 °
DWR ID	DWR_ST0012_01_f_ 2015_13				
Action/Comments					
Schedule repair of erosion site prior to the next inspection.

Perspective view of the erosion on the landward side of the levee looking upstream. Fall 2015.

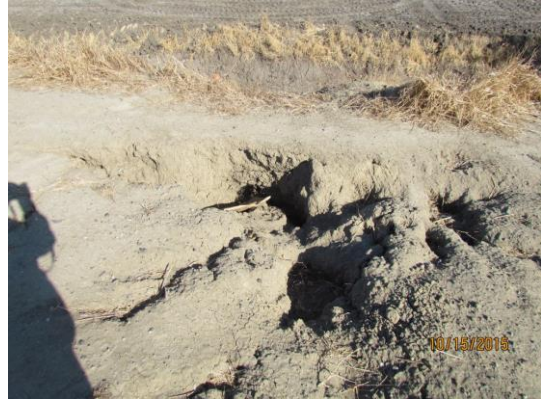
Photo 2 of 3 : FA\_2015\_ST0012\_295\_13\_20151019\_00011.jpg

LM Start	3.04	Rating **	U	Issue No.	13 (cont)
LM End	3.04	Issue Type +	Ma	Location *	LS
Category	Earthen Levee			GPS Latitude/Longitude	
				Start	End
Item	Erosion / Bank Caving			38.590660 °	38.590660 °
				-121.721460 °	-121.721460 °
DWR ID	DWR_ST0012_01_f_2015_13				
Action/Comments					
Schedule repair of erosion site prior to the next inspection.

Close up view of the erosion on the landward side of the levee. Fall 2015.

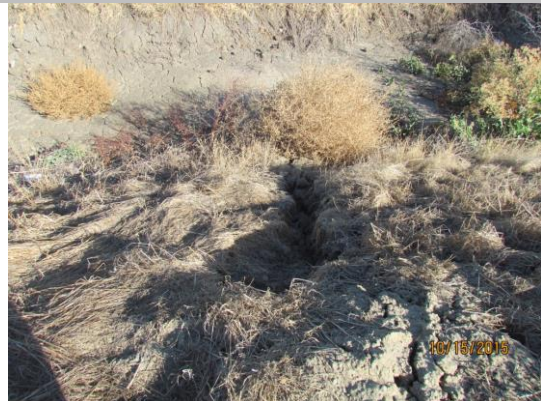
Photo 3 of 3 : FA\_2015\_ST0012\_295\_13\_20151019\_00012.jpg

The erosion continues onto the slope of the channel. Fall 2015.

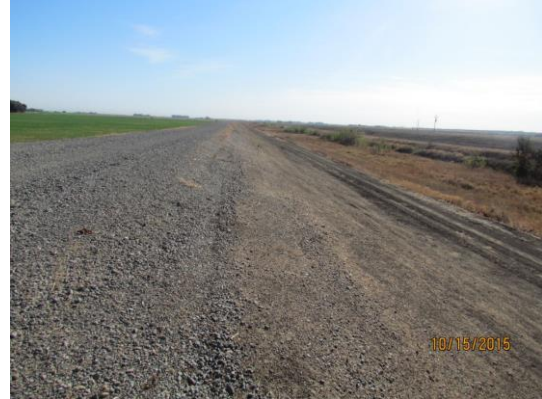
Photo 1 of 1 : FA\_2015\_ST0012\_295\_5\_20151019\_00005.jpg

LM Start	3.50	Rating **	A	Issue No.	5
LM End	5.05	Issue Type +	Ma	Location *	WS
Category	Earthen Levee			GPS Latitude/Longitude	
				Start	End
Item	Vegetation			38.590709 °	38.599967 °
				-121.729829 °	-121.753108 °
DWR ID	DWR_ST0012_01_f_2015_5				
Action/Comments					
Control annual grass and weeds on the levee slopes and easements. Inspector Comments: Sac Yard has burned and dragged the slope.

View of the vegetation on the waterward side of the levee looking downstream. Fall 2015.

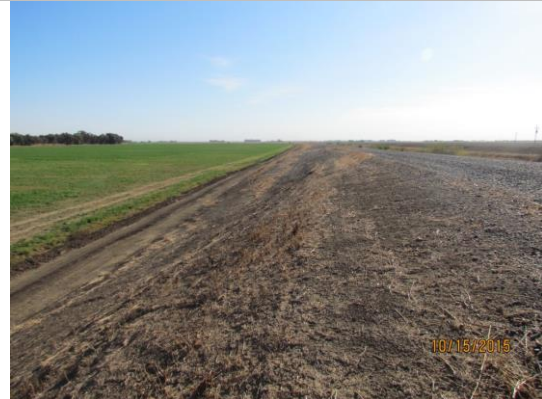
Photo 1 of 1 : FA\_2015\_ST0012\_295\_3\_20151019\_00004.jpg

LM Start	3.50	Rating **	A	Issue No.	3
LM End	5.05	Issue Type +	Ma	Location *	LS
Category	Earthen Levee			GPS Latitude/Longitude	
				Start	End
Item	Vegetation			38.590709 °	38.599967 °
				-121.729829 °	-121.753109 °
DWR ID	DWR_ST0012_01_f_2015_3				
Action/Comments					
Control annual grass and weeds on the levee slopes and easements. Inspector Comments: Sac Yard has mowed the slopes.

View of the vegetation on the landward side of the levee looking downstream. Fall 2015.

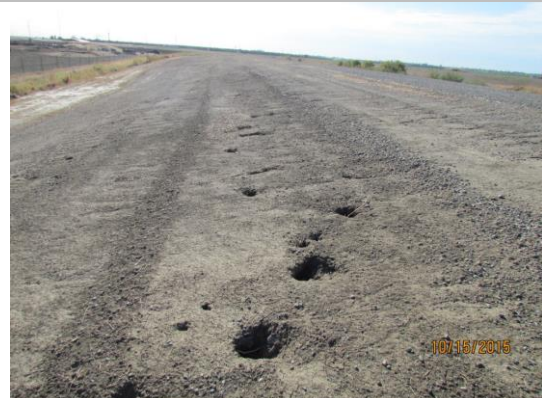
Photo 1 of 1 : FA\_2015\_ST0012\_295\_12\_20151019\_00008.jpg

LM Start	3.90	Rating **	M	Issue No.	12
LM End	3.90	Issue Type +	Ma	Location *	LS
Category	Earthen Levee			GPS Latitude/Longitude	
				Start	End
Item	Animal Control			38.594149 °	38.594149 °
				-121.735254 °	-121.735254 °
DWR ID	DWR_ST0012_01_f_2015_12				
Action/Comments					
No rodents visible, but rodent burrows visible; need to backfill and compact or grout burrows.

View of the rodent hole on the landward side of the levee looking downstream. Fall 2015.

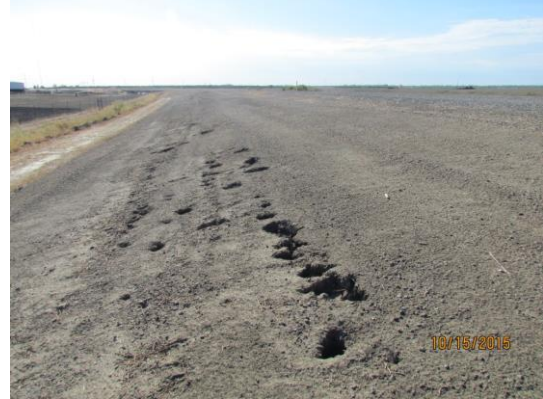
Photo 1 of 1 : FA\_2015\_ST0012\_295\_11\_20151019\_00007.jpg

LM Start	3.94	Rating **	M	Issue No.	11
LM End	3.94	Issue Type +	Ma	Location *	LS
Category	Earthen Levee			GPS Latitude/Longitude	
				Start	End
Item	Animal Control			38.594645 °	38.594645 °
				-121.735712 °	-121.735712 °
DWR ID	DWR_ST0012_01_f_2015_11				
Action/Comments					
No rodents visible, but rodent burrows visible; need to backfill and compact or grout burrows. Inspector Comments: Connected rodent holes seem to have caved in.

View of the rodent holes on the landward side of the levee looking downstream. Fall 2015.

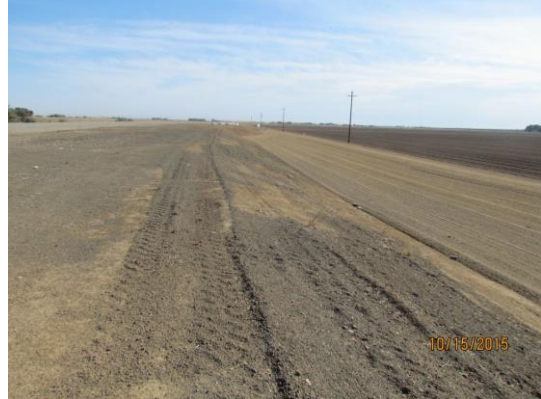
Photo 1 of 1 : FA\_2015\_ST0012\_296\_4\_20151019\_00015.jpg

LM Start	0.00	Rating **	A	Issue No.	4
LM End	7.46	Issue Type +	Ma	Location *	LS
Category	Earthen Levee			GPS Latitude/Longitude	
				Start	End
Item	Vegetation			38.598969 °	38.574366 °
				-121.754383 °	-121.638744 °
DWR ID	DWR_ST0012_02_f_2015_4				
Action/Comments					
Control annual grass and weeds on the levee slopes and easements. Inspector Comments: LMA has maintained levee slope and in compliance.

View of the vegetation on the landward side of the levee looking downstream. Fall 2015.

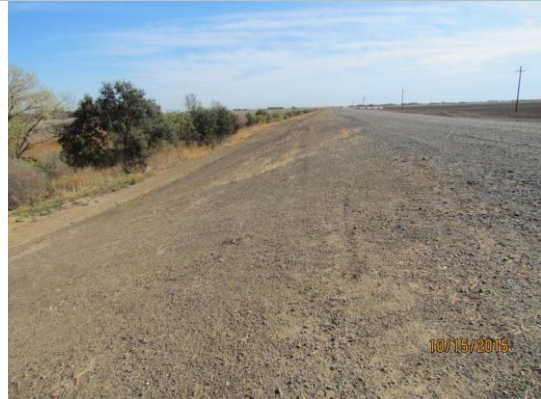
Photo 1 of 1 : FA\_2015\_ST0012\_296\_6\_20151019\_00014.jpg

LM Start	0.00	Rating **	A	Issue No.	6
LM End	7.46	Issue Type +	Ma	Location *	WS
Category	Earthen Levee			GPS Latitude/Longitude	
				Start	End
Item	Vegetation			38.598969 °	38.574366 °
				-121.754383 °	-121.638744 °
DWR ID	DWR_ST0012_02_f_2015_6				
Action/Comments					
Control annual grass and weeds on the levee slopes and easements. Inspector Comments: LMA has maintained levee slope and in compliance.

View of the vegetation on the waterward side of the levee looking downstream. Fall 2015.

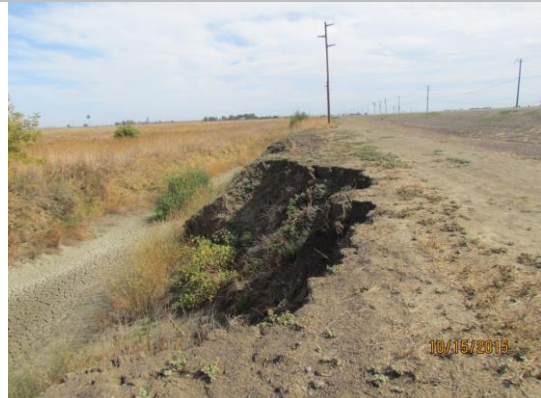
Photo 1 of 1 : FA\_2015\_ST0012\_296\_8\_20151019\_00018.jpg

LM Start	1.77	Rating **	M	Issue No.	8
LM End	1.77	Issue Type +	Ma	Location *	WS
Category	Earthen Levee			GPS Latitude/Longitude	
				Start	End
Item	Erosion / Bank Caving			38.589966 °	38.589966 °
				-121.727072 °	-121.727072 °
DWR ID	DWR_ST0012_02_s_2012_8				
Action/Comments					
Note and monitor erosion site.

View of the erosion on the edge of the channel looking downstream. Fall 2015.

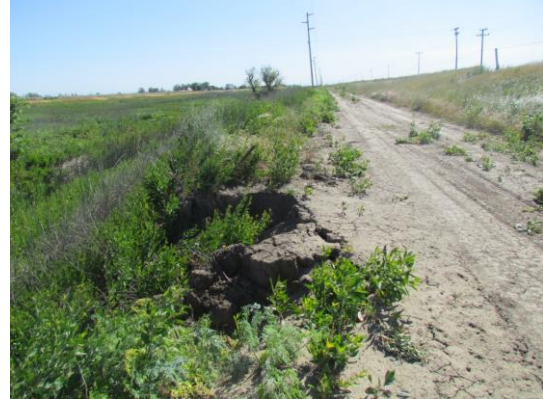
Photo 1 of 2 : FA\_2015\_ST0012\_296\_5\_20150914\_00001.jpg

LM Start	2.04	Rating **	M	Issue No.	5
LM End	2.04	Issue Type +	Ma	Location *	WS
Category	Earthen Levee			GPS Latitude/Longitude	
				Start	End
Item	Erosion / Bank Caving			38.589906 °	38.589906 °
				-121.722218 °	-121.722218 °
DWR ID	DWR_ST0012_02_s_2012_5				
Action/Comments					
Note and monitor erosion site.

View of the erosion on the edge of the channel on the water ward side of the levee looking downstream. Spring 2015.

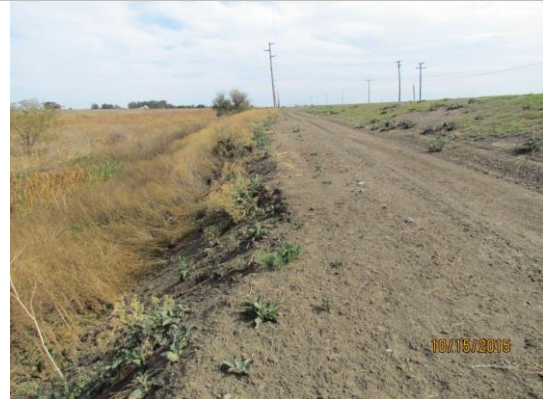
Photo 2 of 2 : FA\_2015\_ST0012\_296\_5\_20151019\_00019.jpg

View of the erosion on the edge of the channel on the waterward side of the levee looking downstream. Fall 2015.

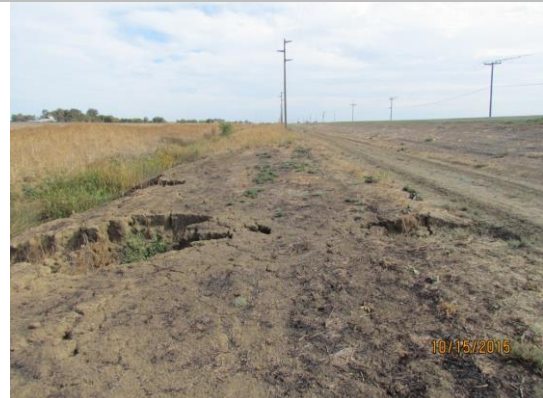
Photo 1 of 1 : FA\_2015\_ST0012\_296\_19\_20151019\_00020.jpg

LM Start	2.25	Rating **	M	Issue No.	19
LM End	2.25	Issue Type +	Ma	Location *	WS
Category	Earthen Levee			GPS Latitude/Longitude	
				Start	End
Item	Erosion / Bank Caving			38.589845 °	38.589845 °
				-121.718292 °	-121.718292 °
DWR ID	DWR_ST0012_02_f_2015_19				
Action/Comments					
Note and monitor erosion site.					
Inspector Comments: Erosion creeping onto toe road.

View of the erosion at the edge of the channel on the waterward side of the levee looking downstream. Fall 2015.

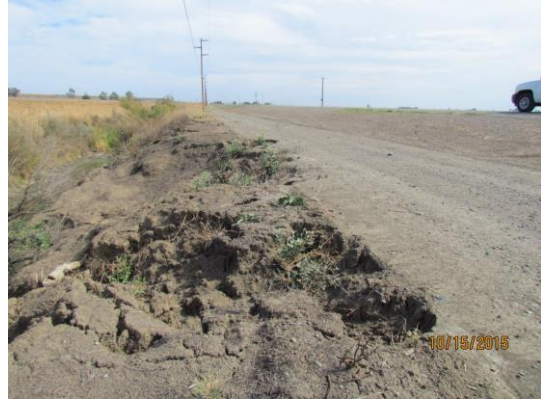
Photo 1 of 1 : FA\_2015\_ST0012\_296\_20\_20151019\_00021.jpg

LM Start	2.73	Rating **	M	Issue No.	20
LM End	2.73	Issue Type +	Ma	Location *	WS
Category	Earthen Levee			GPS Latitude/Longitude	
				Start	End
Item	Erosion / Bank Caving			38.589707 °	38.589707 °
				-121.709429 °	-121.709429 °
DWR ID	DWR_ST0012_02_f_2015_20				
Action/Comments					
Note and monitor erosion site.					
Inspector Comments: Erosion starting to creep onto the toe road.

View of the erosion at the edge of the channel looking downstream. Fall 2015.

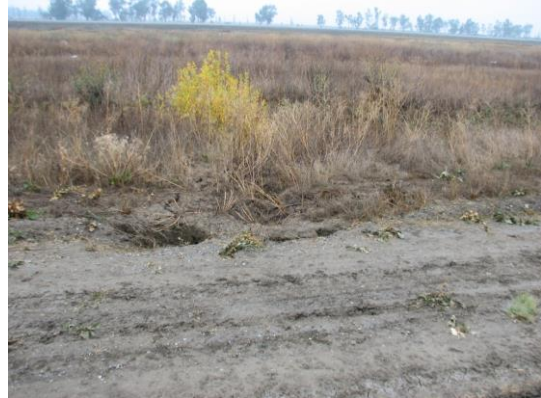
Photo 1 of 1 : FA\_2015\_ST0012\_296\_10\_20150914\_00006.jpg

LM Start	2.82	Rating **	M	Issue No.	10
LM End	2.82	Issue Type +	Ma	Location *	WS
Category	Earthen Levee			GPS Latitude/Longitude	
				Start	End
Item	Erosion / Bank Caving			38.589691 °	38.589691 °
				-121.707740 °	-121.707740 °
DWR ID	DWR_ST0012_02_f_2014_10				
Action/Comments					
Note and monitor erosion site.

Erosion on toe road. Fall 2014.

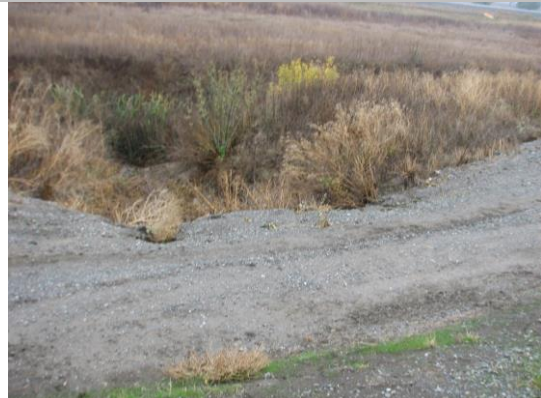
Photo 1 of 2 : FA\_2015\_ST0012\_296\_9\_20150914\_00005.jpg

LM Start	2.97	Rating **	M	Issue No.	9
LM End	2.97	Issue Type +	Ma	Location *	WS
Category	Earthen Levee			GPS Latitude/Longitude	
				Start	End
Item	Erosion / Bank Caving			38.589686 °	38.589686 °
				-121.705041 °	-121.705041 °
DWR ID	DWR_ST0012_02_f_2014_9				
Action/Comments					
Note and monitor erosion site.

Erosion on toe road. Fall 2014.

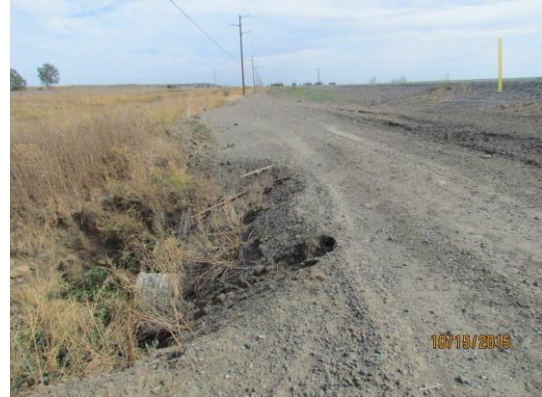
Photo 2 of 2 : FA\_2015\_ST0012\_296\_9\_20151019\_00022.jpg

LM Start	2.97	Rating **	M	Issue No.	9 (cont)	
LM End	2.97	Issue Type +	Ma	Location *	WS	
Category	Earthen Levee			GPS Latitude/Longitude		
				Start	End	
Item	Erosion / Bank Caving			38.589686 °	38.589686 °	
				-121.705041 °	-121.705041 °	
DWR ID	DWR_ST0012_02_f_ 2014_9					
Action/Comments						
Note and monitor erosion site.

View of the erosion on the waterward side of the levee looking downstream. Fall 2015.

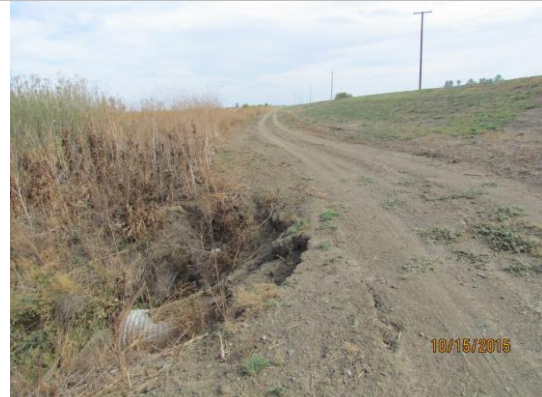
Photo 1 of 1 : FA\_2015\_ST0012\_296\_11\_20151019\_00023.jpg

LM Start	4.29	Rating **	M	Issue No.	11
LM End	4.29	Issue Type +	Ma	Location *	WS
Category	Earthen Levee			GPS Latitude/Longitude	
				Start	End
Item	Erosion / Bank Caving			38.589550 °	38.589550 °
				-121.680632 °	-121.680632 °
DWR ID	DWR_ST0012_02_f_ 2014_11				
Action/Comments					
Note and monitor erosion site.

View of the erosion at the edge of the channel on the waterward side of the levee looking downstream. Fall 2015.

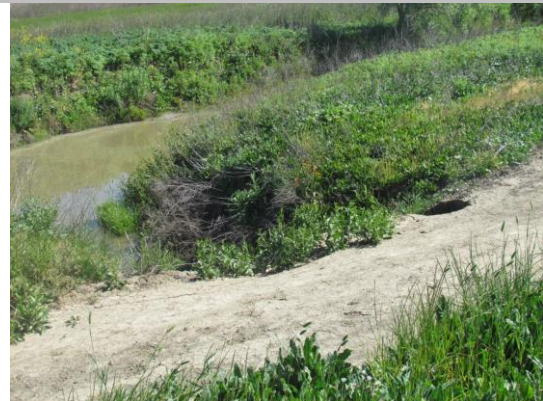
Photo 1 of 2 : FA\_2015\_ST0012\_296\_15\_20150914\_00011.jpg

LM Start	5.05	Rating **	M	Issue No.	15
LM End	5.05	Issue Type +	Ma	Location *	WS
Category	Earthen Levee			GPS Latitude/Longitude	
				Start	End
Item	Erosion / Bank Caving			38.589570 °	38.589570 °
				-121.666588 °	-121.666588 °
DWR ID	DWR_ST0012_02_s _ 2015_15				
Action/Comments					
Note and monitor erosion site.

View of the erosion on the edge of the channel on the waterward side of the levee. Spring 2015.

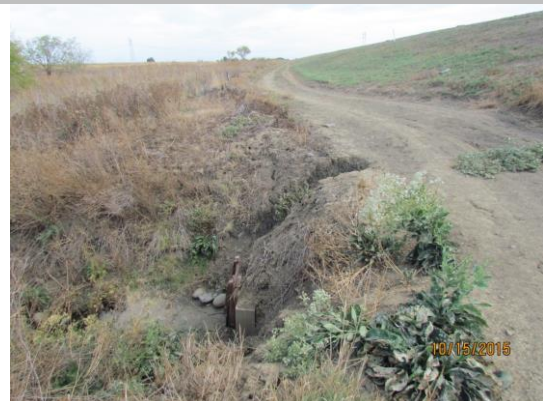
Photo 2 of 2 : FA\_2015\_ST0012\_296\_15\_20151019\_00025.jpg

View of the erosion at the edge of the channel on the waterward side of the levee looking downstream. Fall 2015.

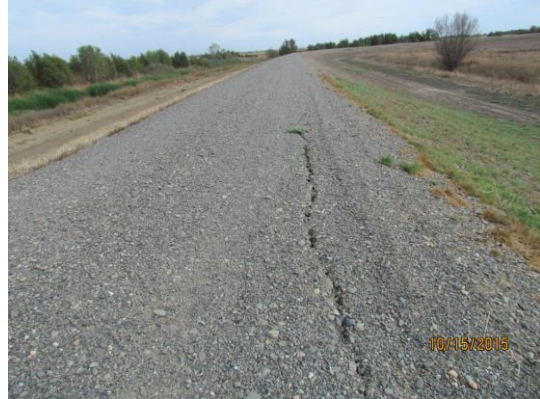
Photo 1 of 1 : FA\_2015\_ST0012\_296\_23\_20151019\_00027.jpg

LM Start	5.93	Rating **	M	Issue No.	23
LM End	5.93	Issue Type +	Ma	Location *	CR
Category	Earthen Levee			GPS Latitude/Longitude	
				Start	End
Item	Cracking			38.589462 °	38.589462 °
				-121.650240 °	-121.650240 °
DWR ID	DWR_ST0012_02_f_2015_23				
Action/Comments					
Monitor and have inspected by geotechnical engineer.

View of the crack on the levee crown looking downstream. Fall 2015.
